LARGE CULVERT STUDIES IN MONTANA

Prepared for
Montana Highway Commission
Planning Survey Section
in cooperation with
U . S . Department of Transportation
Bureau of Public Roads

Alfred C . Scheer

1968

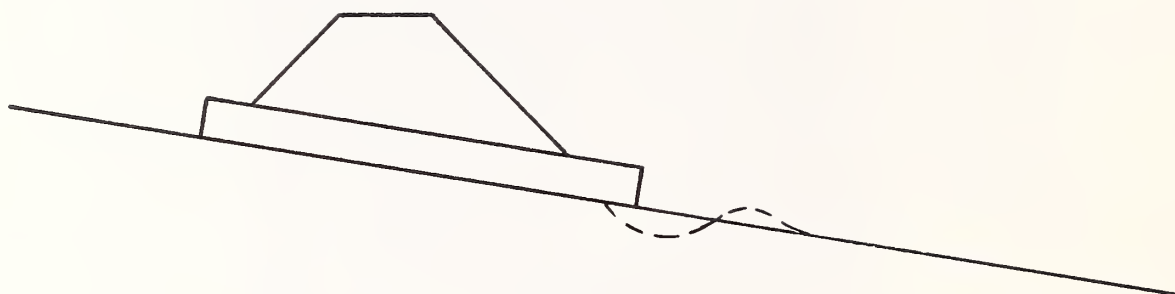
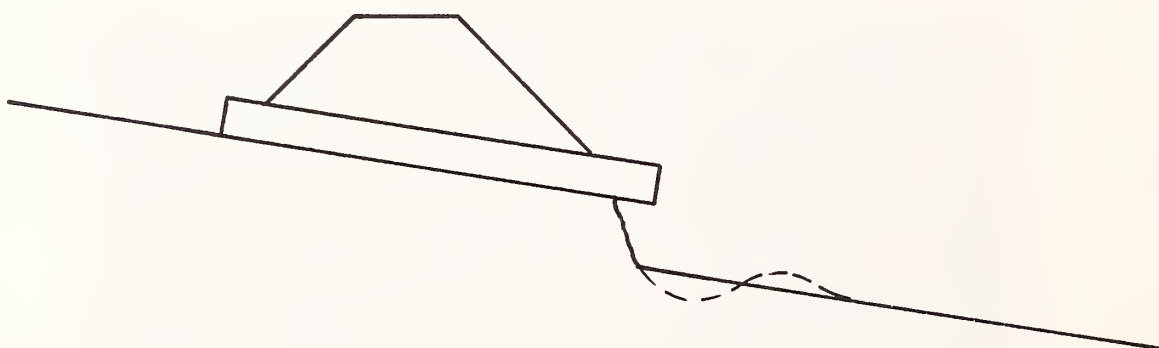
FIGURE 5. TWO TYPES OF DOWNSTREAM CHANNEL PROFILES

It is not always apparent, by visual inspection, whether or not channel degradation has occurred downstream from a culvert. However, when a culvert-streambed profile is plotted, the appearance of the profile will usually permit an accurate judgment to be made. The difference in profile, between an undegraded and a degraded channel, is illustrated in Figure 5.

Streambed profile levels, taken as part of the large culvert surveys, were plotted on graph paper. Downstream channel profiles of the type illustrated in Figure 5 (a) were then classified as stable, and those of the Figure 5 (b) type were classified as degraded. It is possible that a few channels were wrongly classified as stable because the profile levels were seldom carried more than 200 feet beyond the outlet. It is recognized that channel degradation may start at a control station located many hundreds of feet downstream from the culvert, and gradually work upstream to the culvert outlet.

(a) Undegraded downstream channel, with or without scour hole

(b) Degraded downstream channel, with or without scour hole

Seven of the project culverts¹ exhibited downstream channel degradation, with a streambed profile like that of Figure 5 (b). In three of these cases, the depth of channel degradation was less than 2-1/2 feet and the erosion damage appeared to be of little consequence. However, the remaining four² showed pronounced erosion damage. Pictures of the outlets and downstream channels of all four of these installations are shown in Figures 6 through 13.

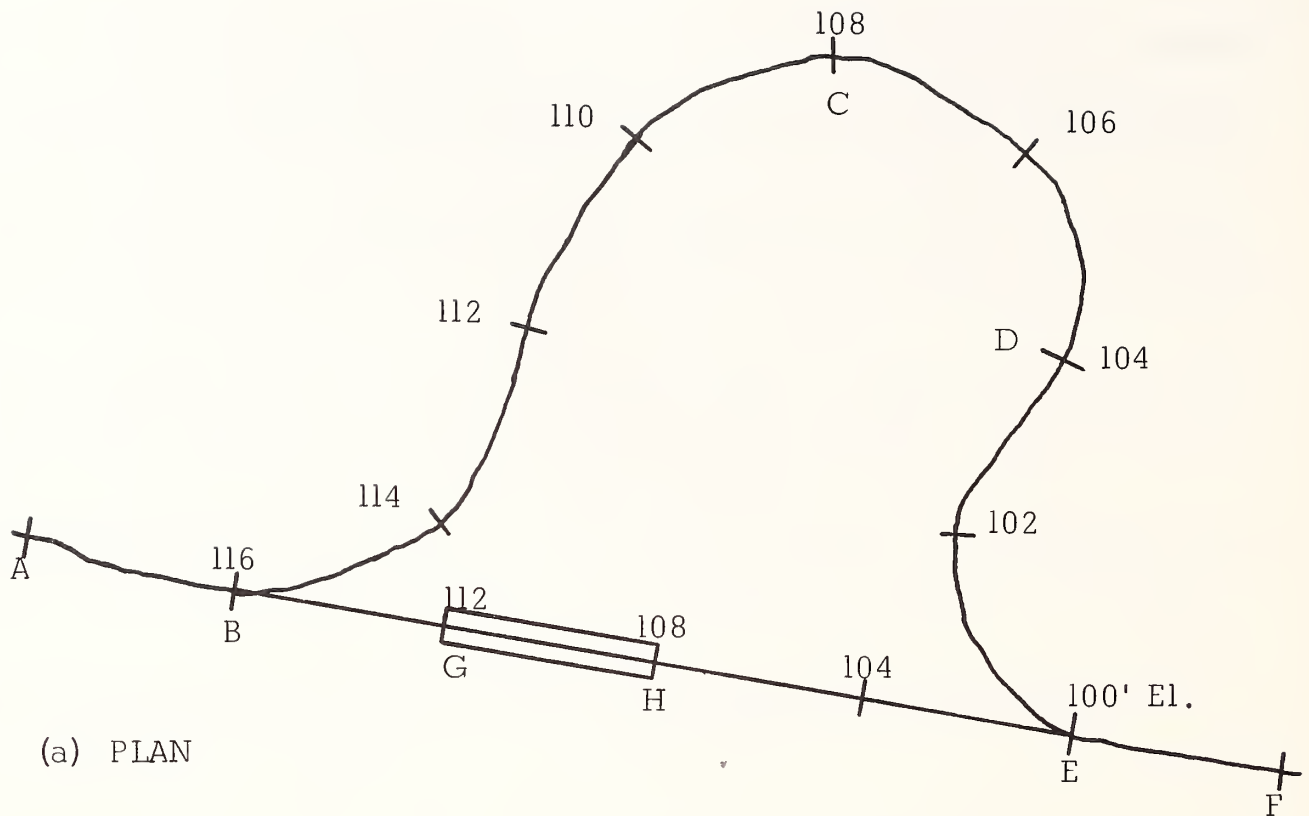
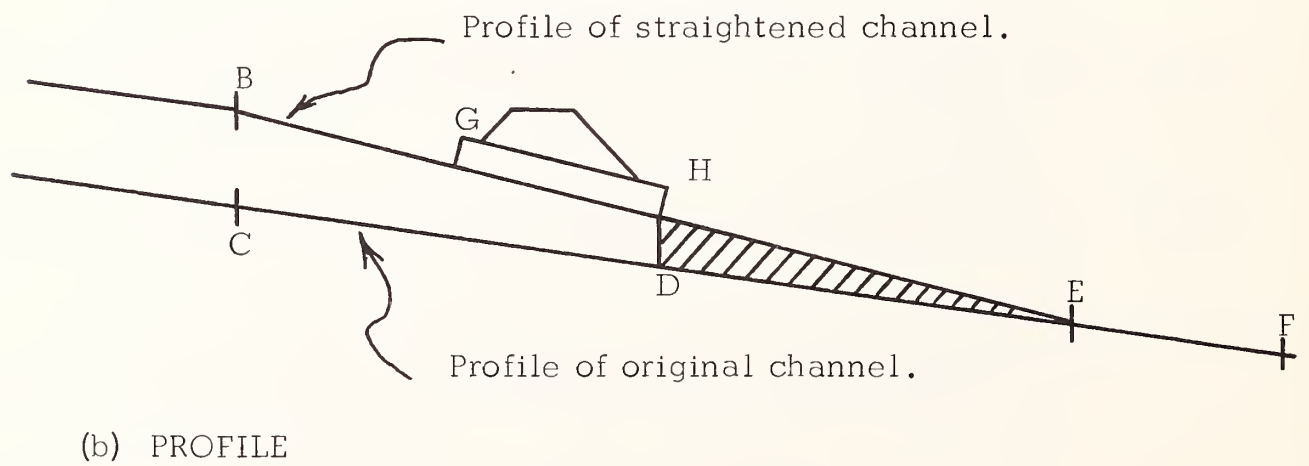
FIGURE 14. PLAN AND PROFILE OF AN IDEALIZED CHANNEL CHANGE

In Figure 14 (a), ABCDEF represents a natural channel on an equilibrium slope of two percent. Bed elevations at 100 foot stations are shown. BGHE represents a 400 foot long channel change which replaces 800 feet of the original channel BCDE. GH represents a 100 foot long culvert installed in the new channel, with inlet and outlet elevations of 112 feet and 108 feet.

The normal discharge, flowing faster than normal down the steep slope HE, will proceed to cut the outlet channel back down to an equilibrium grade of two percent or less. In this case one should expect the equilibrium elevation of the outlet channel at H to be no higher than the elevation of station D in the original channel, namely 104 feet. The 4 foot difference in elevation between H and D thus becomes the minimum expected depth of scour at the

culvert outlet. The shaded zone HDE, on the profile, portrays the minimum expected scour pattern between the culvert and station E.

It is possible to avoid or at least minimize outlet channel degradation, when a culvert is placed in a straightened channel, by cutting the new channel down to the equilibrium slope right at the start. For instance, referring back to Figure 14, if the new channel were excavated on a two percent slope all the way from E to B the culvert outlet would then be four feet lower, with H at the same elevation as D. This would eliminate or reduce the outlet channel degradation problem but it would intensify the scour problem upstream from the culvert where an eight foot high waterfall would now exist near station B. This dilemma could be avoided by extending the channel change upstream on a meandering alignment until it could be connected back into the original channel without any elevation or slope difference. If a channel change were effected in this manner, the length and slope of the new channel would be the same as the length and slope of the old channel.

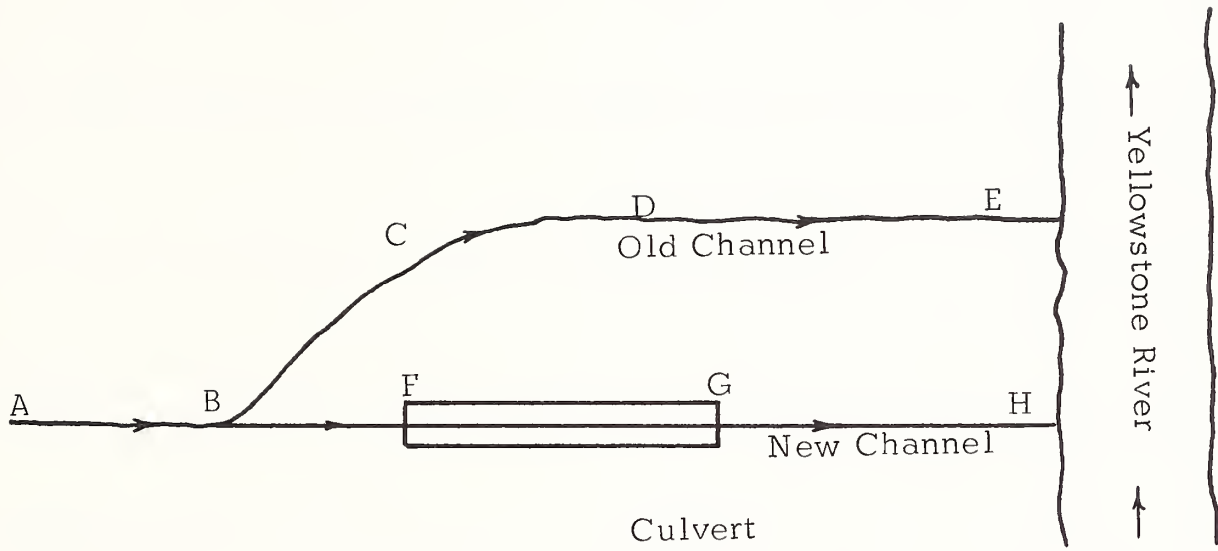
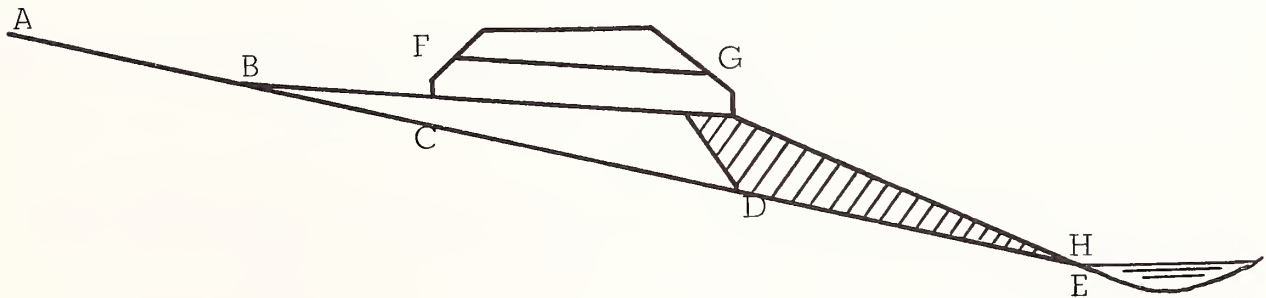
PLAN

The outlet scour problem at project culvert No. 25, shown earlier in Figures 8 and 9, is another particularly interesting case. This culvert has had water backed up six feet above its crown at the inlet and has flowed

The cross-hatched zone
represents gully scour
that has occurred.

almost full at the outlet. It was mentioned earlier that this culvert had a grouted riprap outlet apron that was completely demolished. It was after the loss of the outlet apron that the vertical cutoff wall, visible in Figure 8, was constructed. Only the top six feet of the ten-foot high cutoff wall are visible in the Figure. After construction of the cutoff wall, large rocks were dumped at the culvert outlet, right up against the cutoff wall. Subsequent high water moved the rocks about 50 feet downstream, to the position shown in Figures 8 and 9, where they formed a "dam" across the outlet channel. The large scour basin, which apparently developed as a result of this accidental riprap dam, now threatens to destroy the cutoff wall and the grouted riprap slope-facing by outflanking it and cutting behind it from each end. It appears that the stream could by-pass the riprap dam by cutting a new channel on either side. However, when the culvert was last inspected in June of 1967, the riprap dam was still intact and no significant changes had taken place since 1963 when the pictures of Figures 8 and 9 were taken. One factor which may account for the relatively long life of the riprap dam is that the outlet channel had previously scoured its way down into a moderately erosion-resistant sandstone stratum upon which the riprap dam rests.

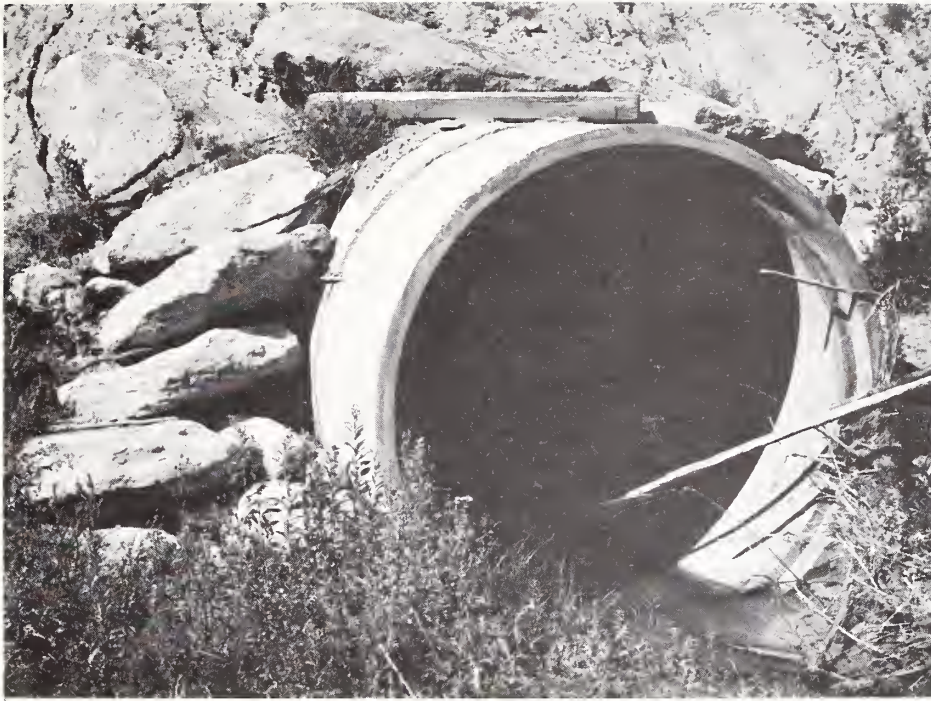
FIGURE 23. INLET OF PROJECT CULVERT NO. 3

Figures 23 and 24 show the inlet end of project culvert No. 3. Notice in particular, the tie-bolt across the joint near the center of Figure 24. The inlet and outlet of culvert No. 4 are shown in Figures 25 and 26 respectively. One of the tie-bolts at the outlet is visible in Figure 26. The pictures were taken in 1963, but the appearance of each culvert remains essentially the same in 1967.

The tie-bolts and cutoff walls appear to be doing their intended jobs perfectly. Both culverts are in excellent condition. There has been no indication of undermining or separation of the end sections in spite of the fact that the soil is highly erodible and each culvert has carried a very heavy flow of water, with the headwater pool above the elevation of the top of the pipe. Fresh evidence of this flood was visible in the summer of 1963 when the

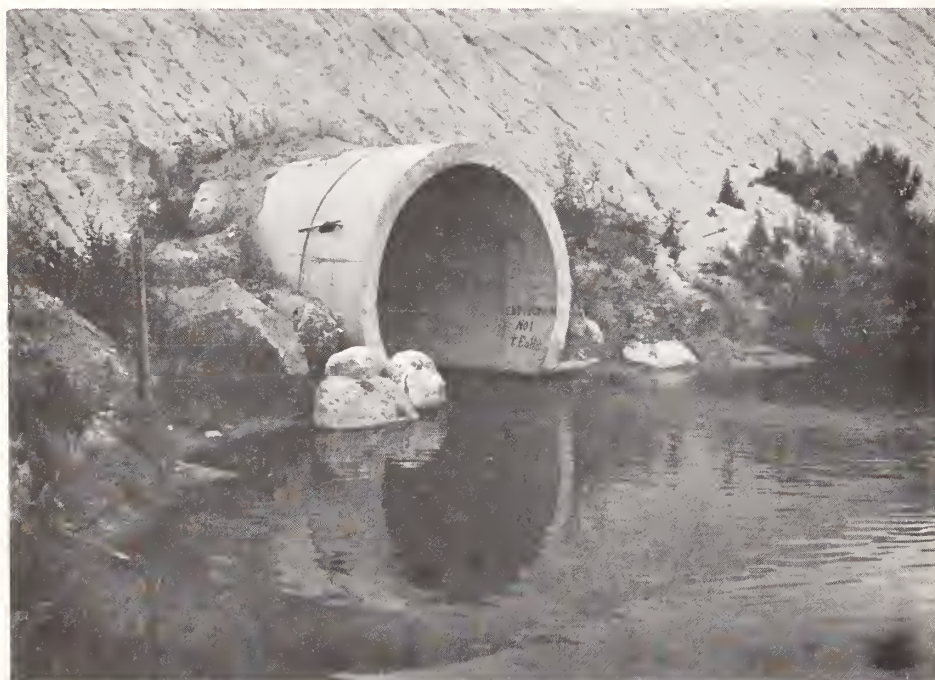
FIGURE 26. OUTLET OF PROJECT CULVERT NO. 4

Heavy sedimentation, of previously very prominent outlet scour holes, was observed at project culverts Nos. 4 and 13 in July of 1967, following a moderately heavy spring runoff of unusually long duration. The runoff receded very slowly as a result of slow melting of heavy mountain snowpacks. At culvert No. 13, a large gravel bar now hides all evidence that a broad and deep scour hole once existed at the site. At culvert No. 4, the external boundaries of the large outlet pool (which is visible in Figure 26) are still

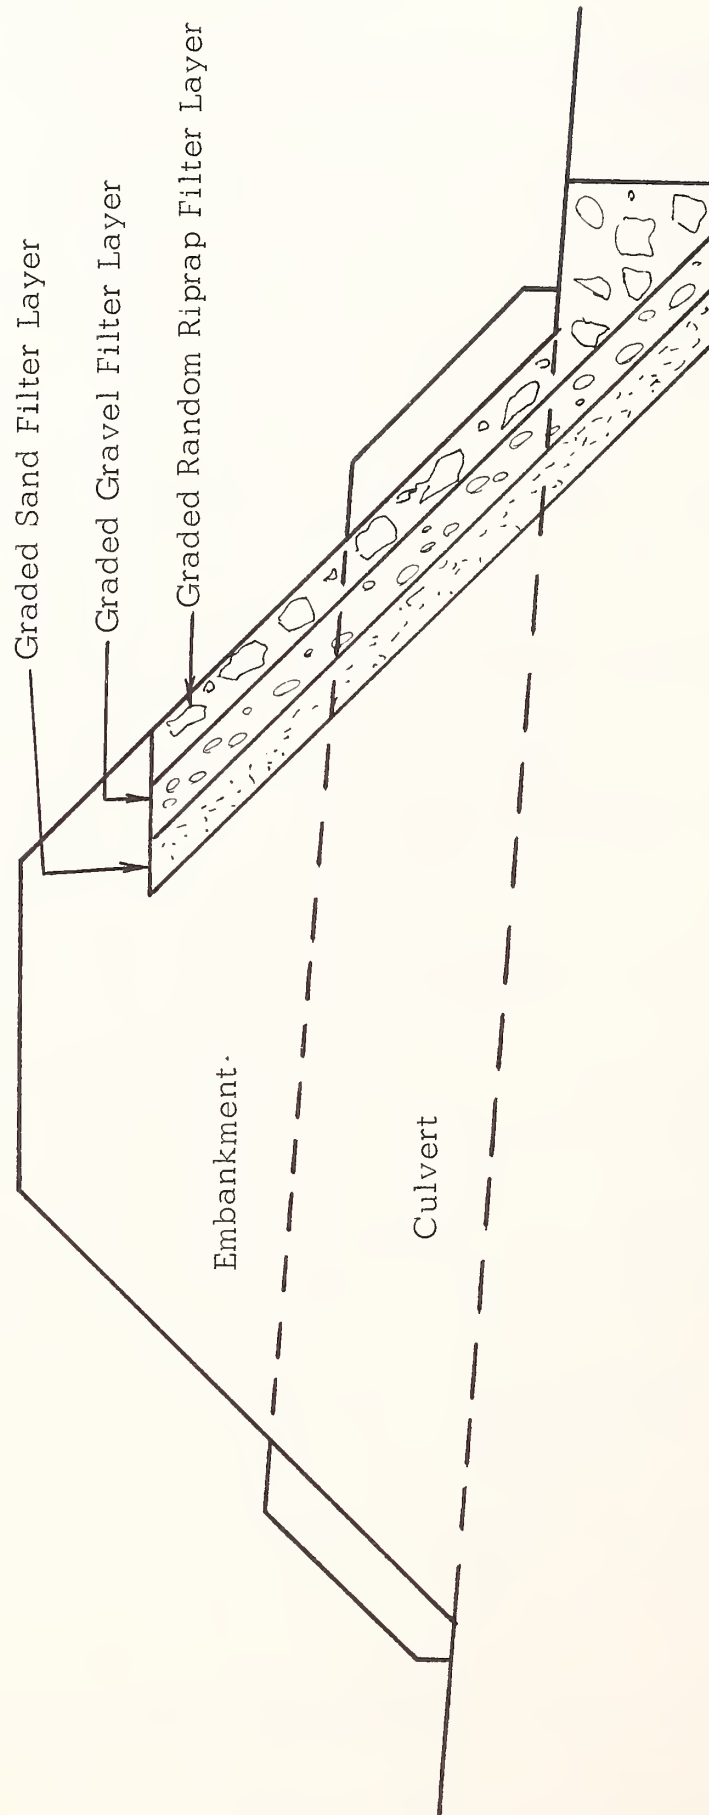
An attempt to study culvert seepage and piping problems quantitatively, with the use of flow nets, would require so many simplifying assumptions that the results would be of no practical use. The lack of watertight joints in culverts is one of the complicating factors and it is also a factor that aggravates the piping danger. If culvert seams were watertight, and if there were no significant internal channels within an embankment to concentrate the flow, then the energy of the seeping water would be dissipated in a safe and gradual manner as it seeped the full length of the culvert, through the small pores of the embankment soil. However, in a culvert with leaky joints, water may flow inside the culvert for almost its full length with very little energy loss and enter the soil under high pressure, through a leaking seam, within only a few feet or a few inches of the outlet.

FIGURE 43. A HYPOTHETICAL CULVERT OUTLET FILTER SYSTEM TO PREVENT PIPING OF A FINE-GRAINED EMBANKMENT SOIL.

piping. A piping channel could then work its way upstream through the embankment, along the leaking seam, for the full length of the culvert. In a qualitative sense, the problem is easy to understand, but it is impossible to make a reliable quantitative estimate of the extent to which leaking seams initiate piping. Early-stage piping should be suspected when one observes a small hole in the soil, at a culvert outlet, near a longitudinal seam.

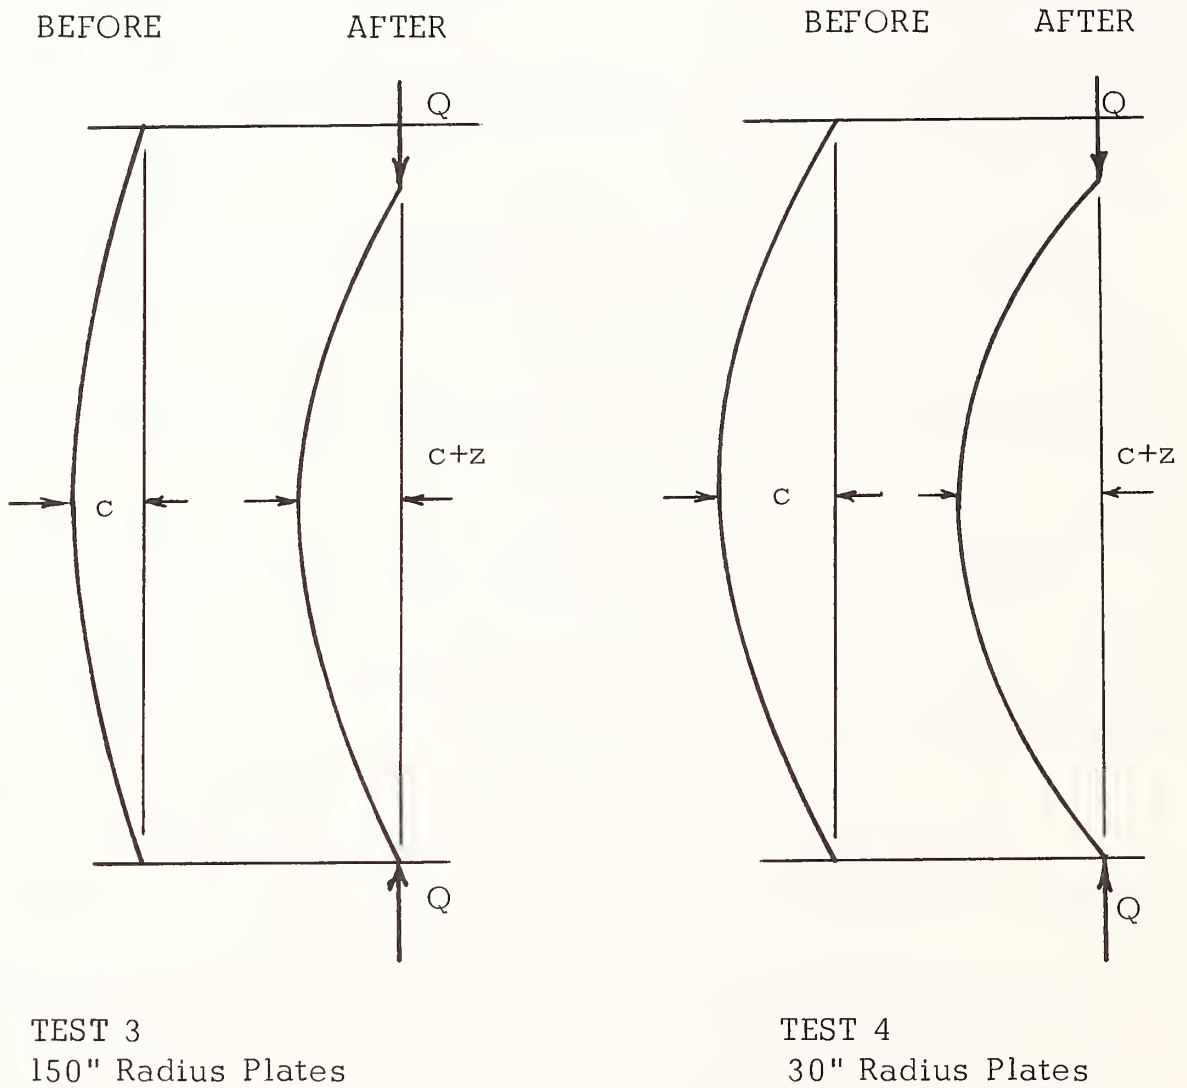
FIGURE 46. STANDARD STRUCTURAL CULVERT PLATES TESTED AS COLUMNS

It may be seen, from Figure 46, that the moments developed at failure for tests three and four, M_{\max} , are equal to the ultimate load, Q , times $(c+z)$.

The sketches show the culvert sections before testing and the deflections at failure for tests three and four in Bulletin 109. z is the horizontal deflection corresponding to the peak load, Q .

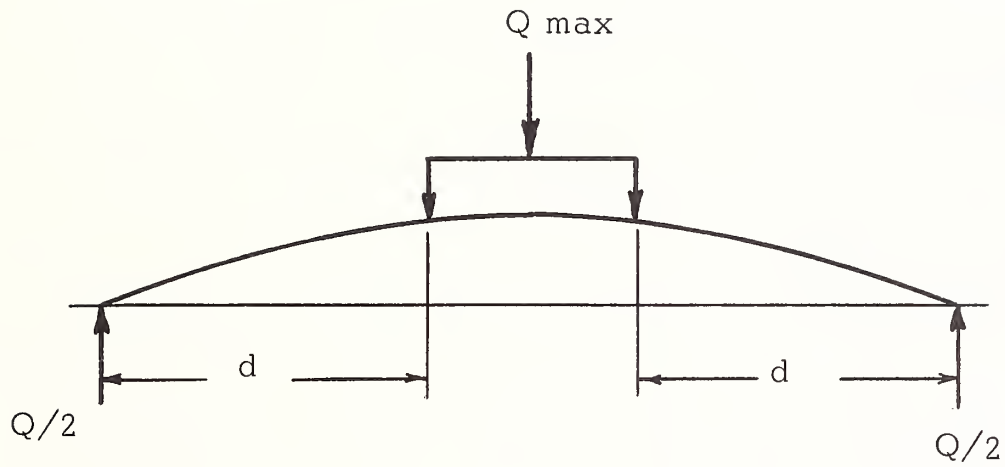
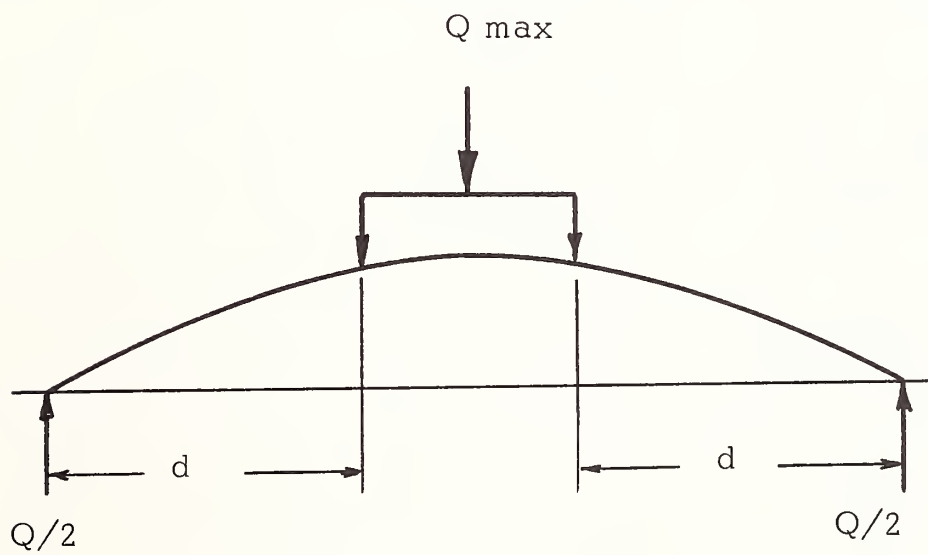
FIGURE 47. CULVERT PLATES TESTED AS SIMPLE BEAMS

Tests five and six were simple beam tests where the specimens were supported at both ends and subjected to a downward force at the center. Test five consisted of 150-inch radius sections while test six had 50-inch radius sections (see Figure 47).

one-half the ultimate load times the distance, d , at the time of failure (see Figure 47).

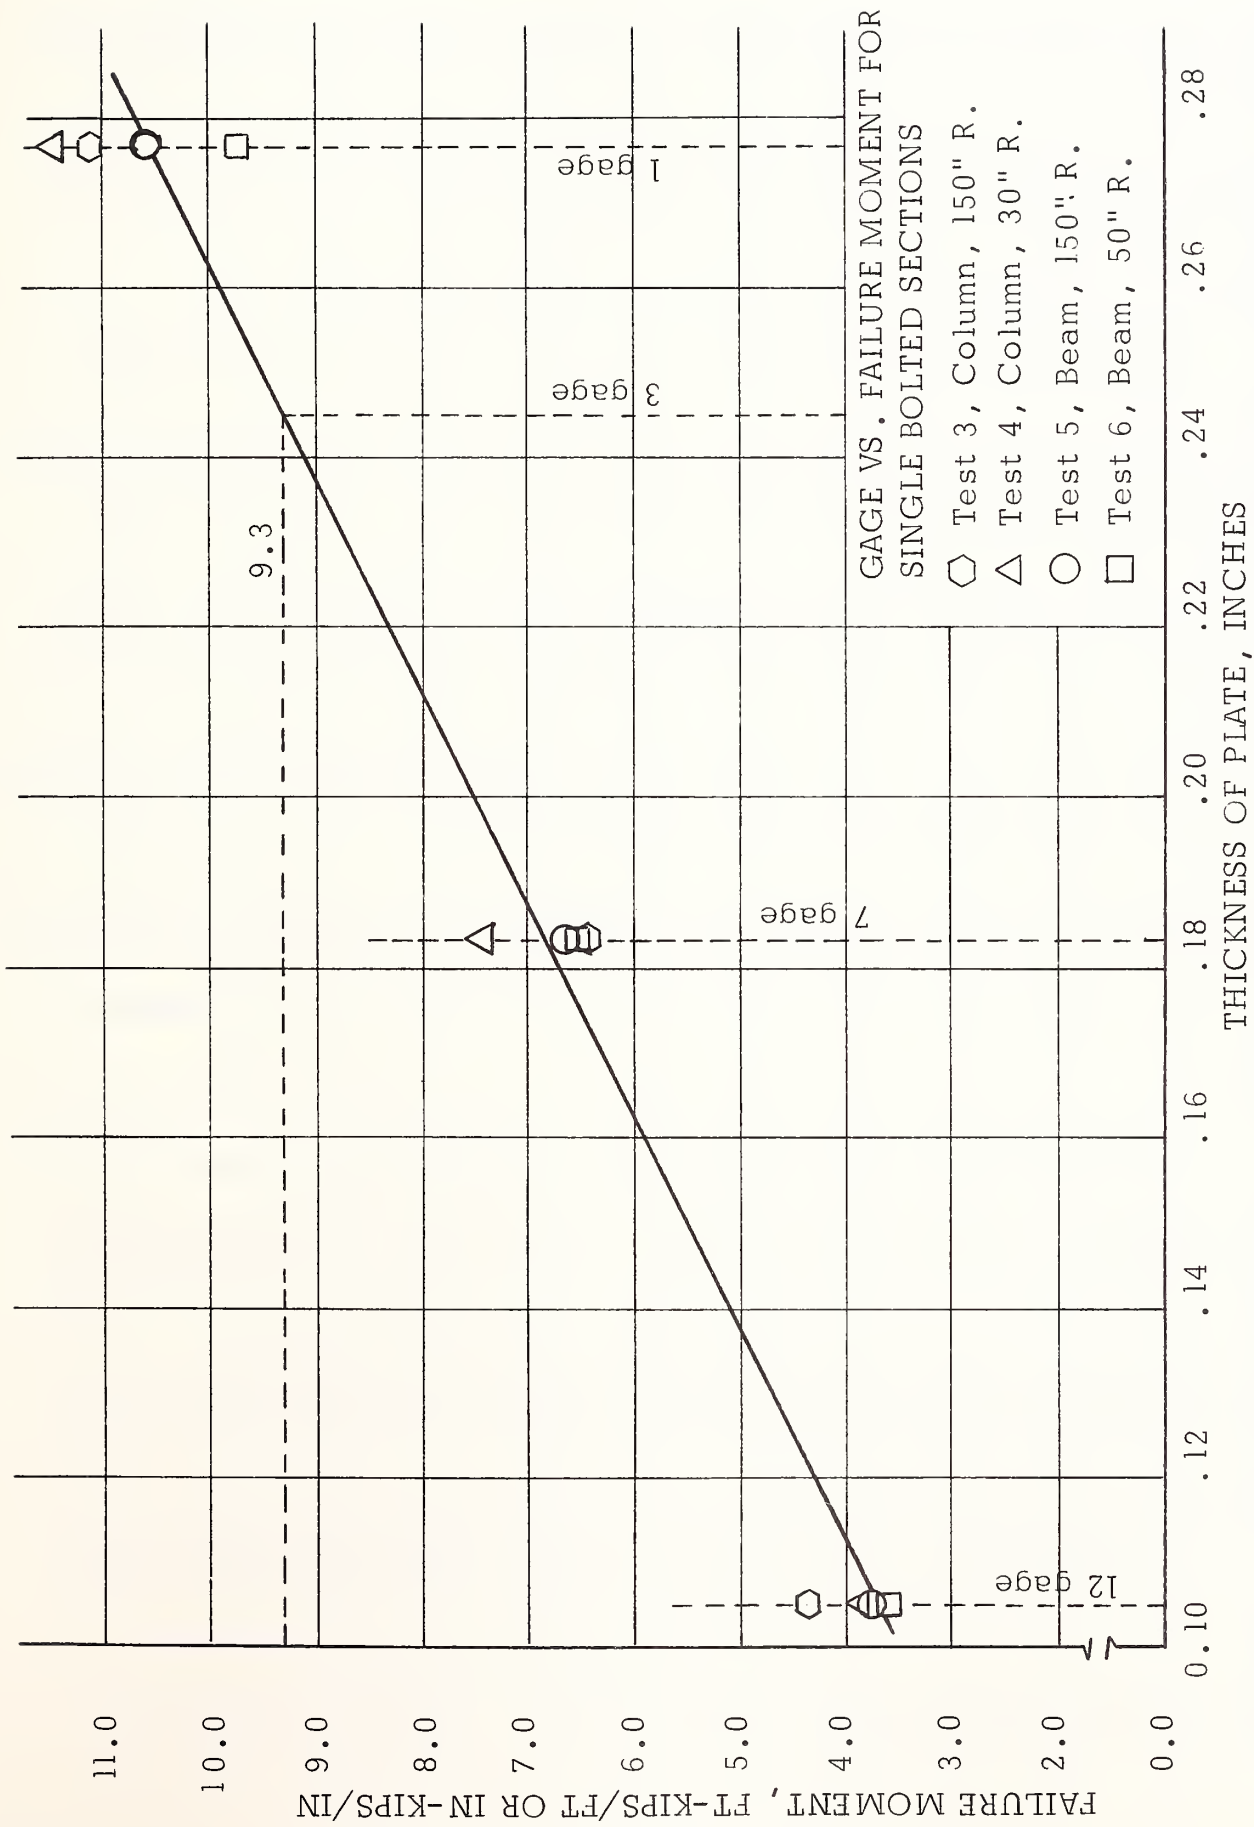
The failure moments, for the bolted seams of Tables 8 and 9, are shown graphically in Figure 48. The plotted points show a highly consistent pattern which conforms well to the straight-line interpretation shown.

FIGURE 48. FAILURE MOMENTS FOR BOLTED STANDARD STRUCTURAL PLATE CULVERT SEAMS, AS CALCULATED FROM DATA GIVEN ON TEST SERIES 3, 4, 5 and 6 IN THE MICHIGAN ENGINEERING EXPERIMENT STATION BULLETIN NO. 109.

The Figure may be used to estimate the moment strength of structural plate seams in any gage between 12 and 1. For example, the moment strength of a single bolted seam constructed of 3-gage plates (0.245 inches thick) is approximately 9.3 foot-kips per foot, according to the graph.
